**TITLE** : Report on the evaluation of the fire propagation properties of **Supacool** under-roof insulation material as supplied by **Technopol** in accordance with **SANS 428** (large-scale) using the **SANS 10177 – 11 Horizontal** test protocol

**REQUESTED BY** : **Technopol SA (Pty) Ltd**  
PO Box 2445  
**SPRINGS**  
1560

**CONTRACT No** : FTC 16/208

**DATE** : 16 November 2016

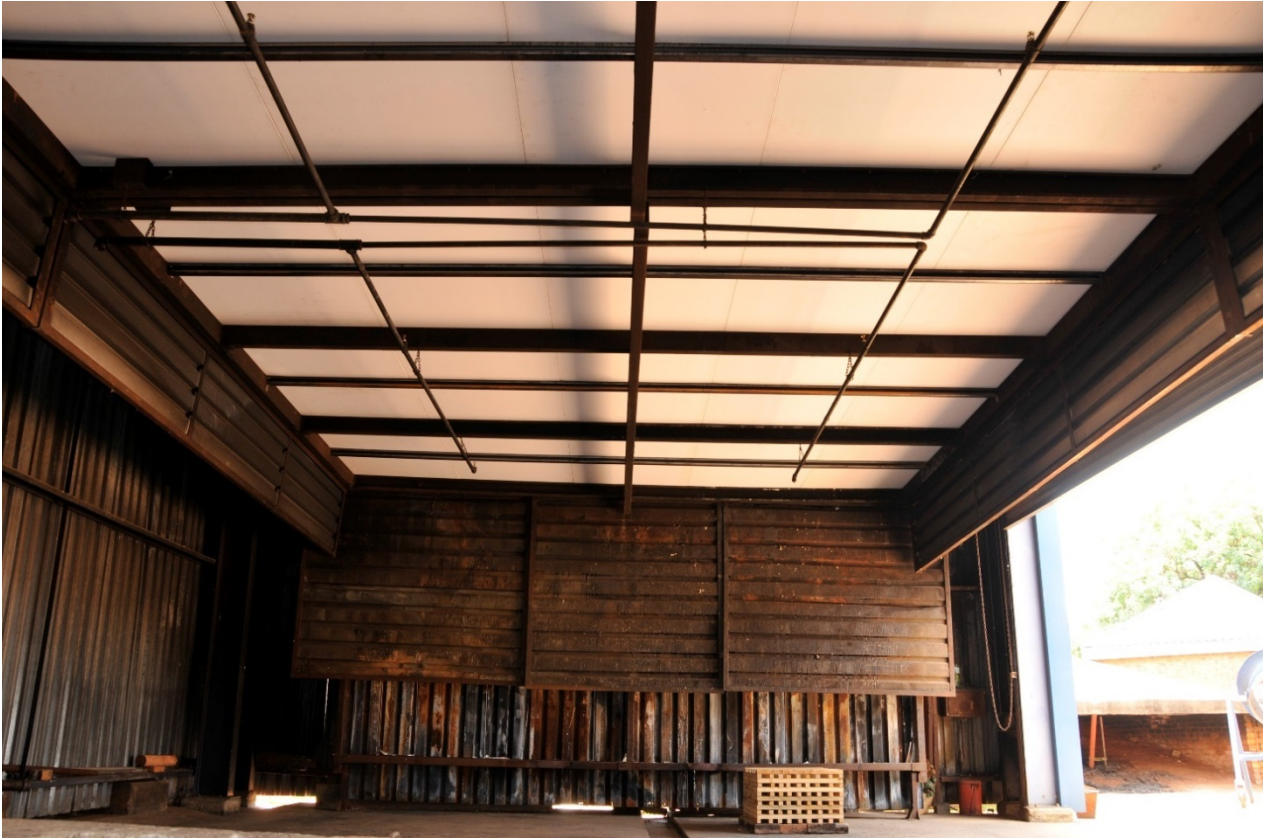
Figure 4.1: The **SANS 10177 – 11** test installation prior to ignition of the Fire Source

The test installation in the **SANS 10177 – 11 Horizontal** facility prior to ignition of the Fire Source crib and after the test was concluded is shown in Figure 4.1 and 4.10 respectively. The temperatures recorded by the thermocouples (TC) during the test are depicted graphically in Figures 4.13 and 4.14.

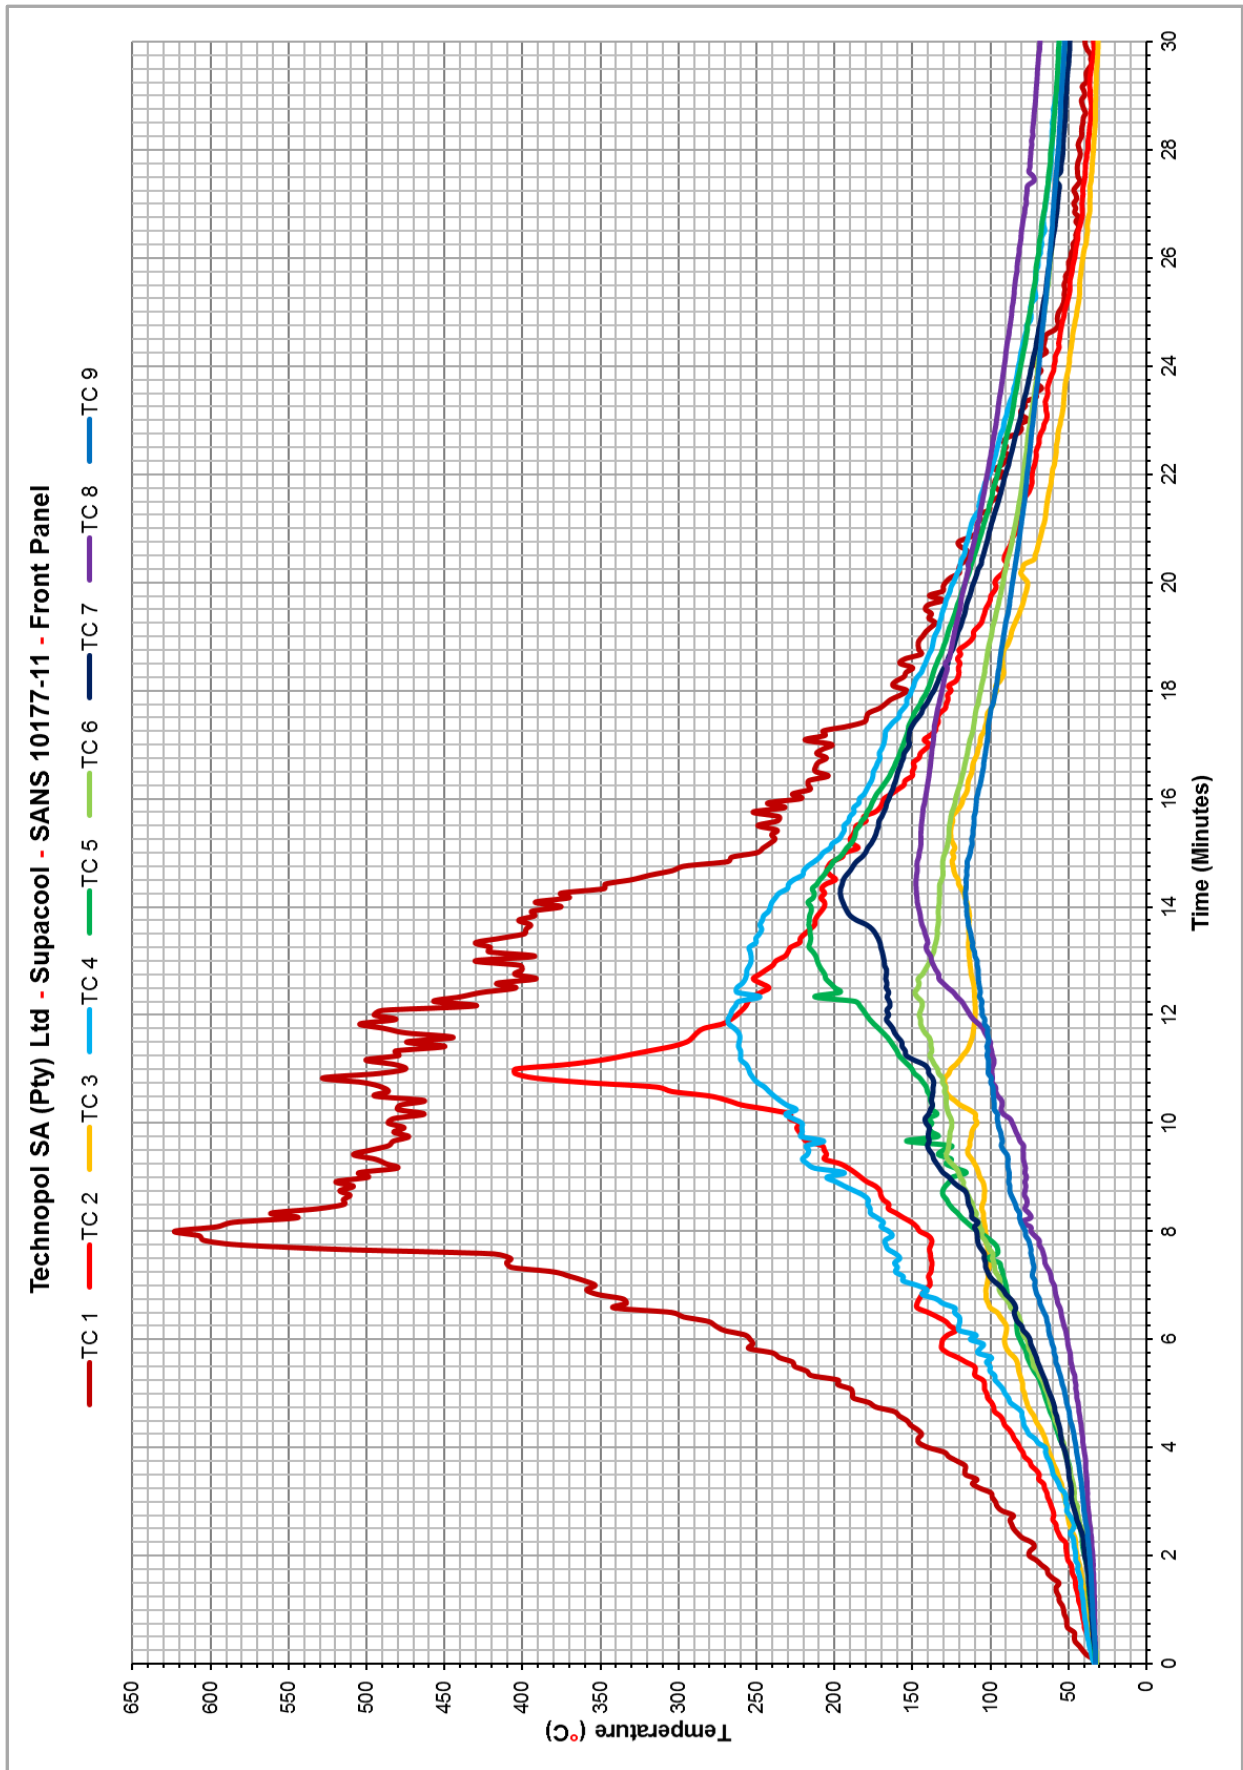
Figure 4.13: Temperatures recorded on the front sample frame during the **SANS 10177 – 11** test
